BURNETT LAKE DAM
SCOTT COUNTY, MISSOURI
MO 40069

**PHASE 1 INSPECTION REPORT
NATIONAL DAM SAFETY PROGRAM**

MARCH 1981

Name of Dam:	Burnett Lake Dam
State Located:	Missouri
Inventory Number:	MO. 40069
County Located:	Scott
Stream:	Unnamed Tributary to Hindman Creek
Date of Inspection:	3 December 1980

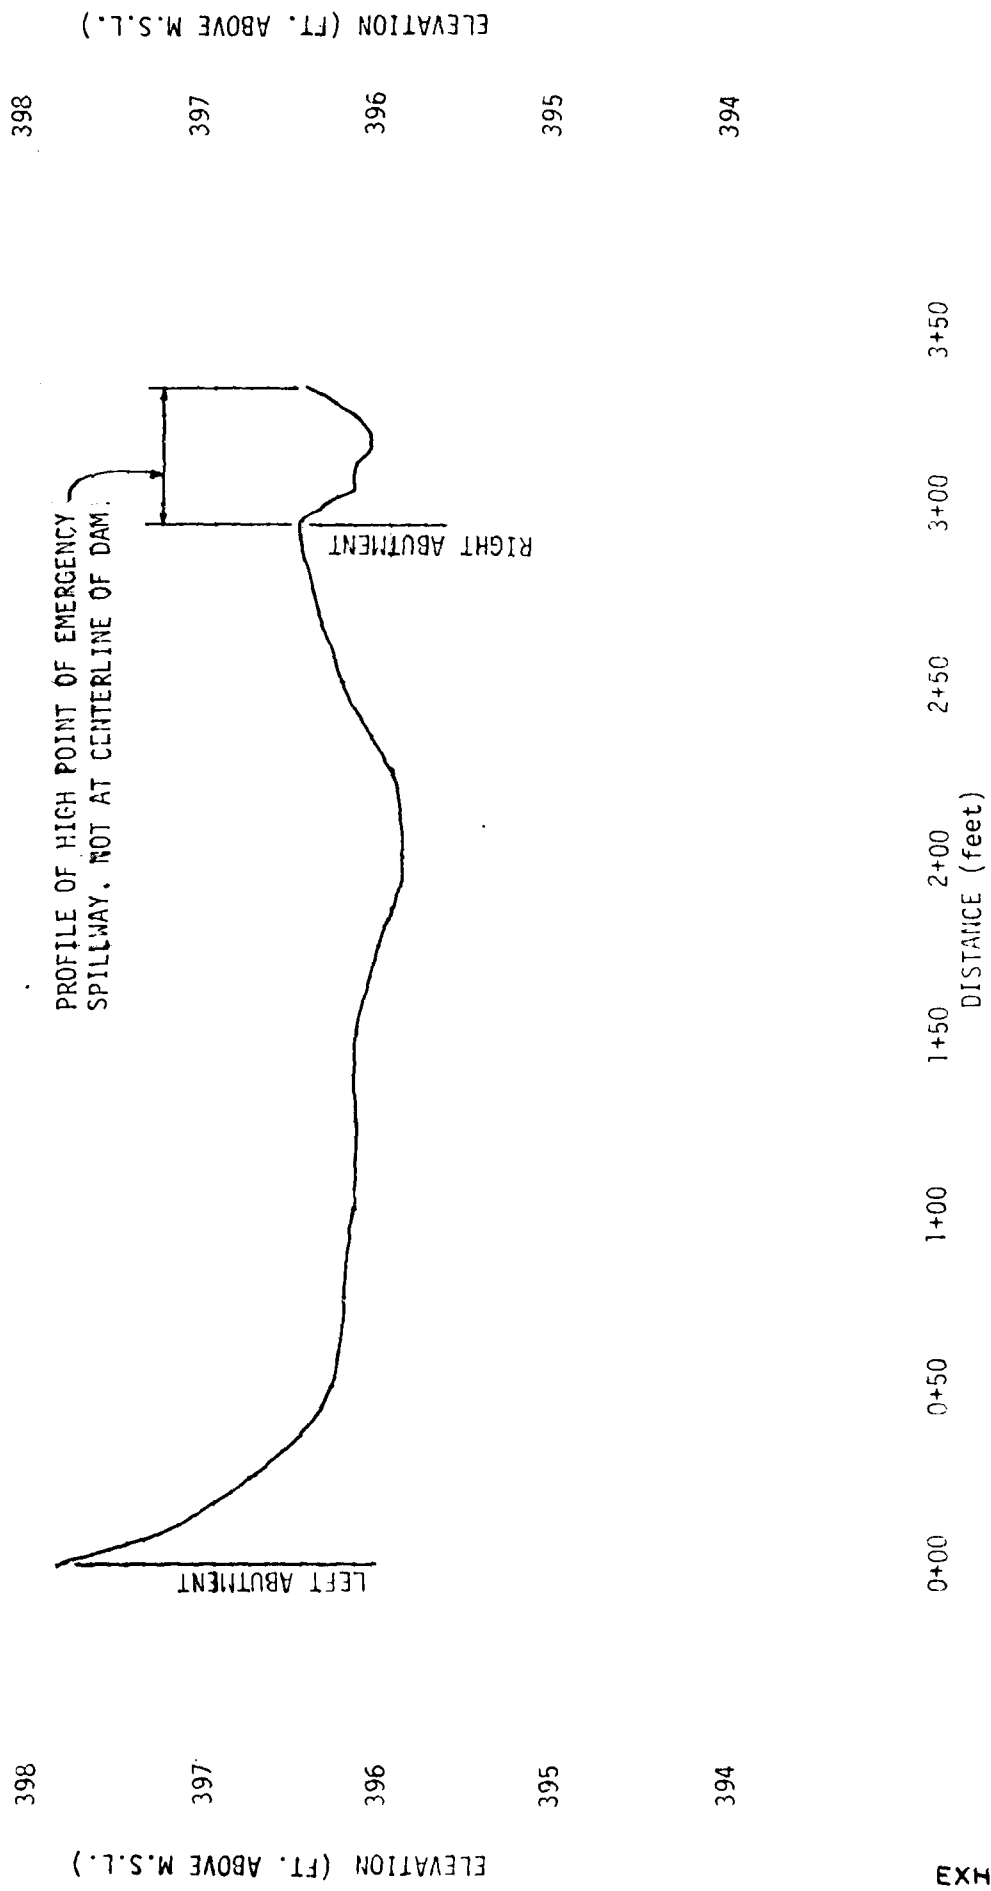
U.S. ARMY ENGINEER DISTRICT, ST. LOUIS CORPS OF ENGINEERS NATIONAL DAM SAFETY PROGRAM	PROFILE OF DAM CREST BURNETT LAKE DAM NO. 40069
--	---	--

The elevation of the centerline of the crest of the dam varies from 395.9 to 397.9. Although there is 2.0 feet of variation in the crest elevation, the visual inspection of the vertical alignment reveals no major problem. Most of the variation appears to be caused by the upward slope of the embankment crest as it approaches the left abutment. Most of the change in elevation occurs within 30 feet of the left abutment. Also some variation in elevation of the crest appears to have been caused by greater settlement where the height of the embankment was greater. The profile of the crest of the dam is shown on Exhibit 3 of Appendix B.
